PHASE I
ENVIRONMENTAL SITE ASSESSMENT
HAZARDOUS SUBSTANCES

TRUST #7659 PROPERTY LLC PROPERTY
NOGALES, ARIZONA
(PARCEL NO. 113-49-027—NORTH)

PREPARED FOR:
SANTA CRUZ COUNTY
2150 N. Congress Drive
Nogales, Arizona 85621

MAY 8, 2009

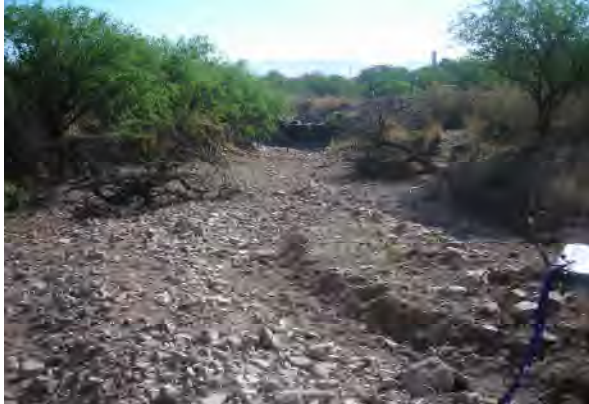
Photograph No. 1

Allwyn Environmental observed solid waste on the subject property. There is an automobile salvage yard that appears to encroach onto the subject property (See Photographs No.4 and 5 in the Photographic Log) on the small narrow strip next to the northern boundary in the northwest portion of the subject property. Allwyn Environmental also observed bullet fragments (See Photographs No.2 and 3) in the vicinity of the Border Patrol Shooting range in the northwest portion of the property (See Photograph No.1).

Subject property (Looking East at wash behind Border Patrol Shooting Range)

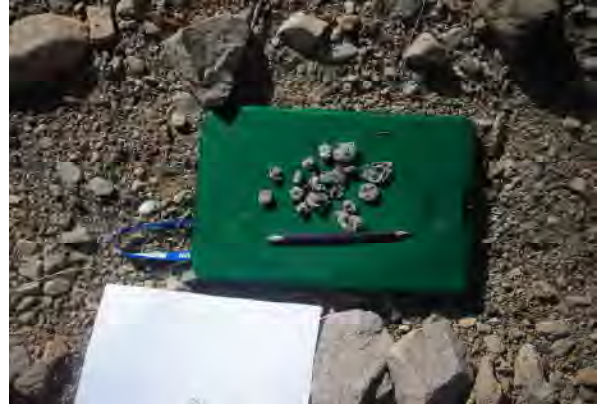
Photograph No. 2

- Bullet fragments were observed on the subject property, in the vicinity of the Border Patrol Shooting range in the northwest portion of the subject property. Bullet fragments varied in size and were found in large concentrations in the wash and hillside directly behind the shooting range. The bullet fragments likely result in elevated concentrations of lead in the soil. Further assessment of the soil through soil sample collection and analysis, and/or alternate means (e.g., X-ray fluorescence) should be conducted to evaluate the extent and magnitude of potential lead impact of the soil.

- Bullet fragments were observed on the subject property, in the vicinity of the Border Patrol Shooting range in the northwest portion of the subject property. Bullet fragments varied in size and were found in large concentrations in the wash and hillside directly behind the shooting range. The bullet fragments likely result in elevated concentrations of lead in the soil. Further assessment of the soil through soil sample collection and analysis, and/or alternate means (e.g., X-ray fluorescence) should be conducted to evaluate the extent and magnitude of potential lead impact of the soil.
- There is an automobile salvage yard that is enclosed within the northwest portion of the subject property and encroaches onto the subject property (See Photographs No. 4 and 5 in the

Bullet fragments found on Subject Property in 6 inch square behind Shooting Range)

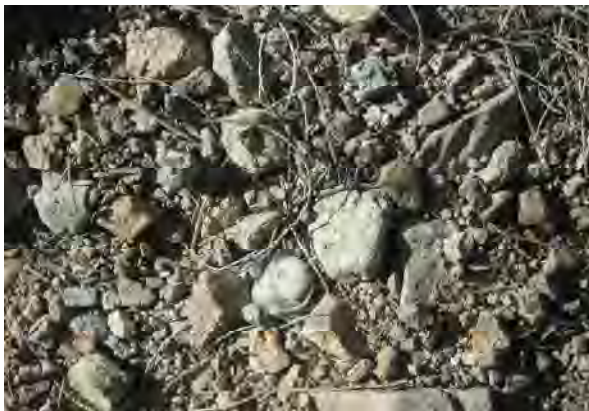
Photograph No. 3

Shotgun wadding, bullet fragments, and casings found behind Shooting Range

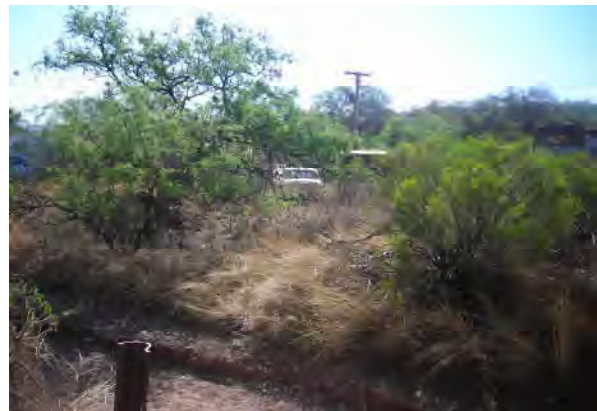
Photograph No. 4

- There is an automobile salvage yard that is enclosed within the northwest portion of the subject property and encroaches onto the subject property (See Photographs No. 4 and 5 in the Photographic Log). The position of the wash and local topography indicates that stormwater, potentially containing petroleum hydrocarbons and metals, could run on and through the subject property from the automobile salvage yard. Soil samples should be collected where stormwater runs onto the property and analyzed for polycyclic aromatic hydrocarbons (PAHs), volatile organic compounds (VOCs), and metals to evaluate the potential impact to soil and/or groundwater.

Subject property (Looking East down Northern Strip from Western Boundary)

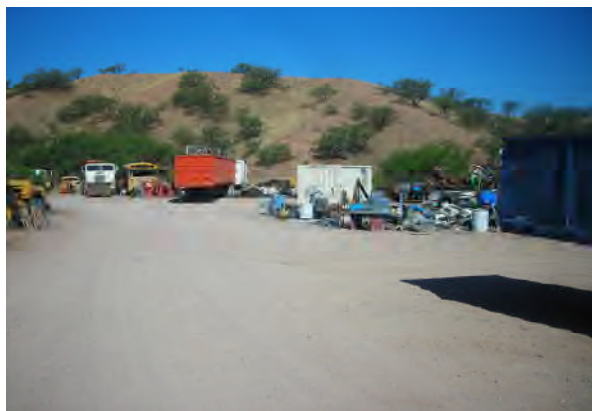
Photograph No. 5
Subject property (Looking West where Auto Salvage Yard encroaches onto Northern Strip)

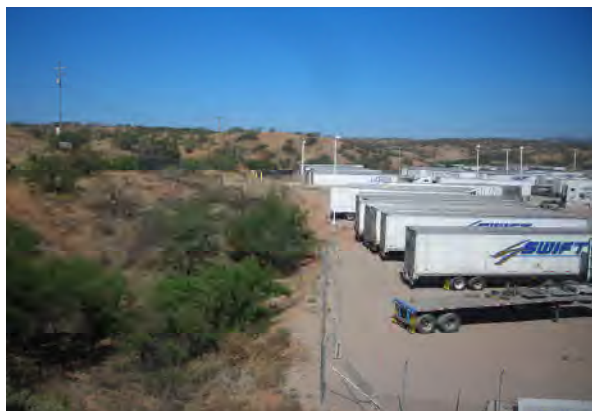
Photograph No. 7
Subject property (Looking West from Northeast corner where fence encroaches onto property)

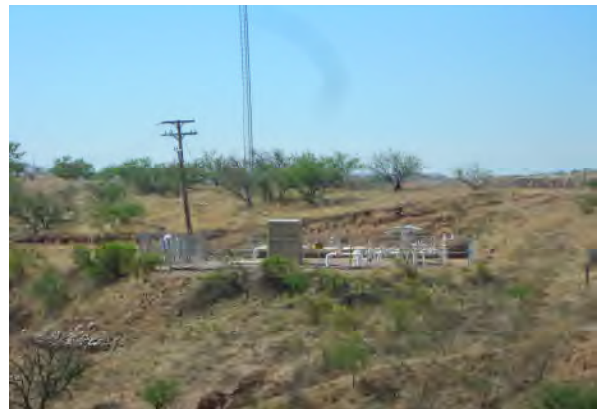
Allwyn Environmental did not detect any strong, pungent, or noxious odors on the property. In addition, records review during the course of this Phase I ESA did not indicate that these features are present on the property. Mr. Jim Barr did indicate that one can, at times, smell natural gas emitting from the Natural gas processing plant, but this occurrence was not observed by Allwyn Environmental.

Photograph No. 12
Natural Gas Processing Plant located on
Southern boundary of Subject Property
