N Not to Scale
	Additional Soil Assessment Trust #7659 Property, LLC; APN 113-49-002B, 113-49-027A, and 113-49-027D; Nogales, Arizona		
	Project Number: 0183-0001 July 8, 2017

Additional Soil Assessment

Trust #7659 Property, LLC; APN 113-49-002B, 113-49-027A, and 113-49-027D; Nogales, Arizona

Project Number: 0183-0001

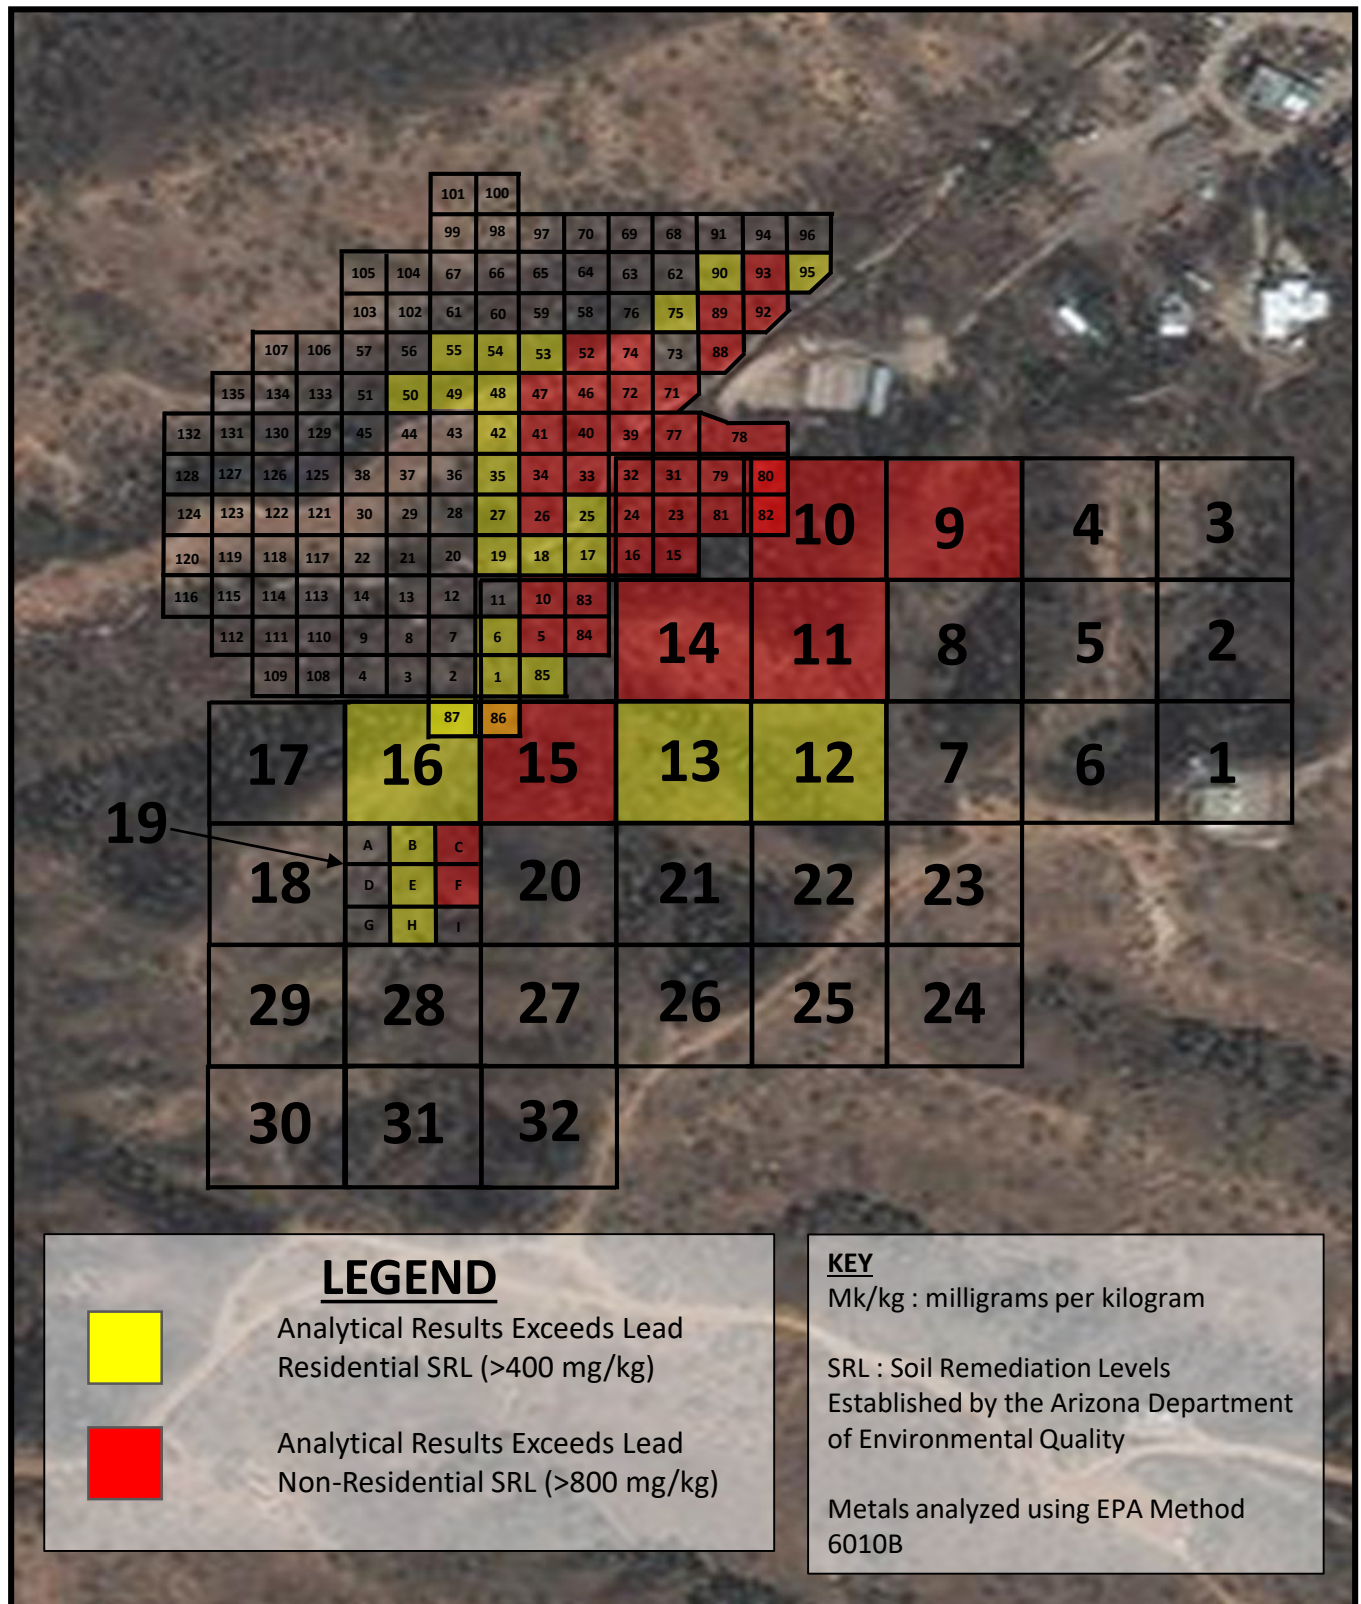
2223 South 48 th Street, Suite A Tempe, Arizona 85282 (602) 900-4941 www.allwynllc.com	Figure 3: Surface Samples Containing Lead in Concentrations Exceeding SRLs	Trust #7569 885 W. Bell Rd., Suite 100 Nogales, Arizona 85621
